**WESTERN FIRE CENTER, INC.**

## Fire Testing of Wood Fencing

**WFCi Report #25060**

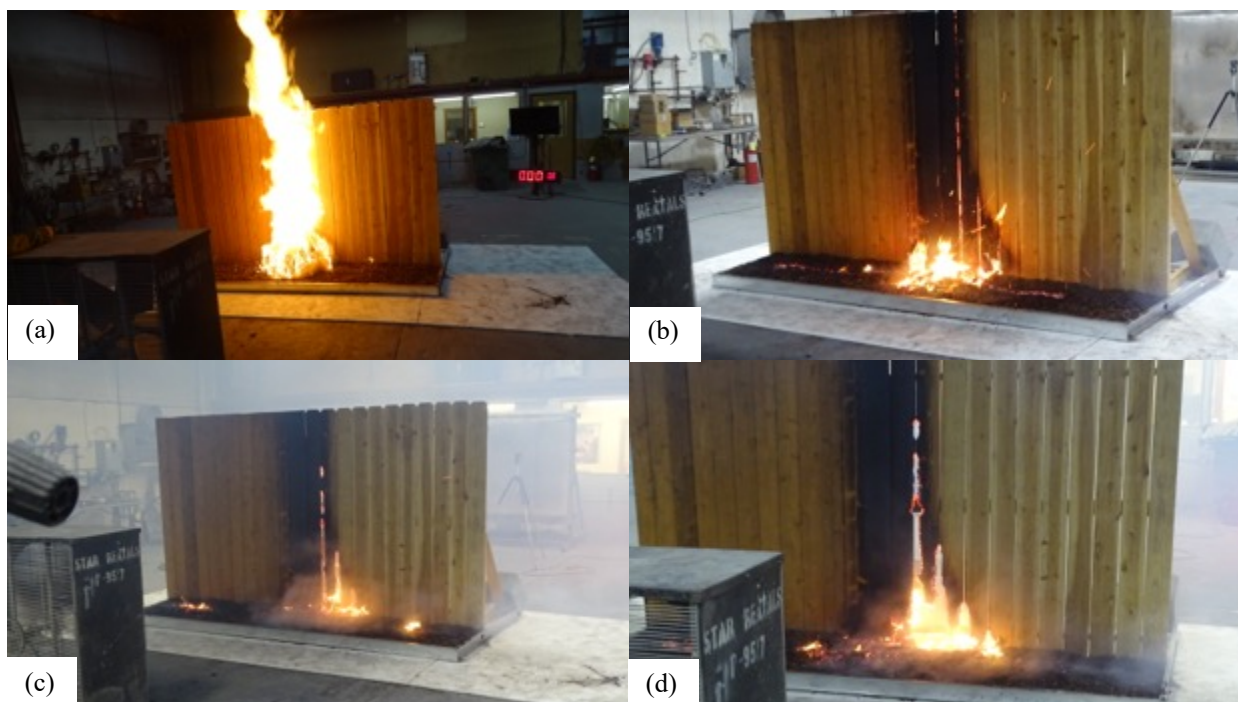
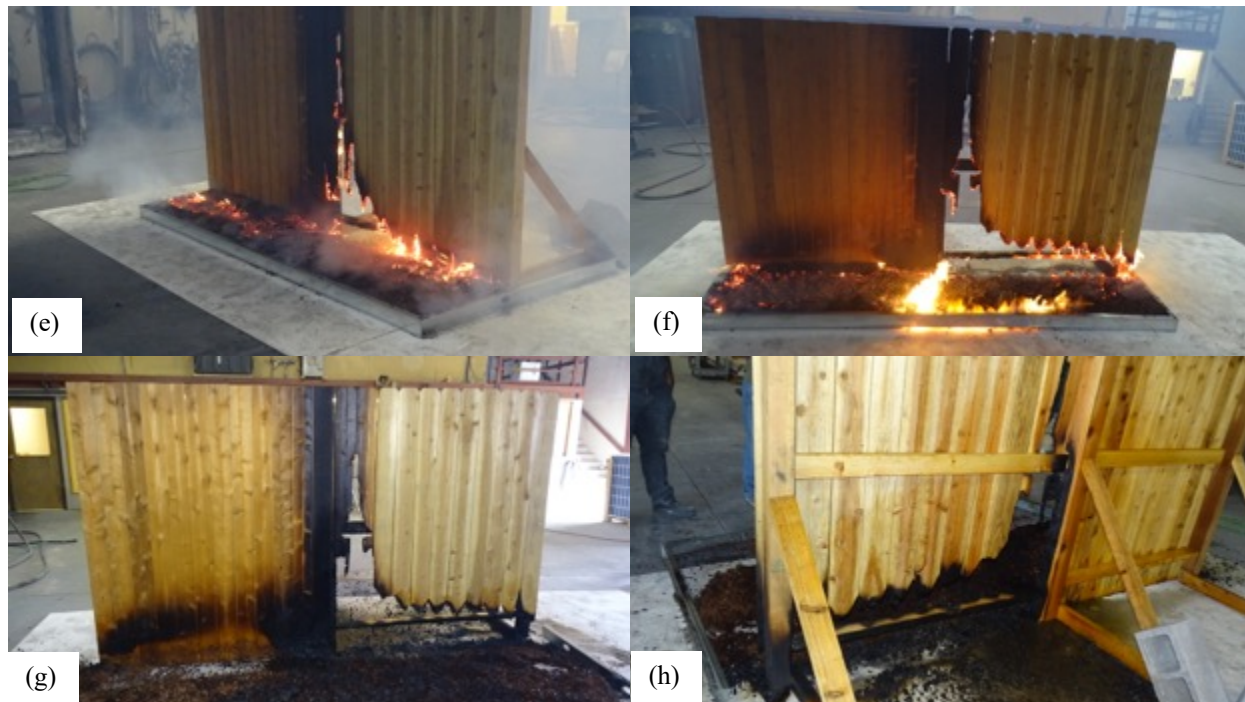
Figure 2. Test 1 showing (a) ignition – 0 min, (b) fan on – 30 s, (c) burning east board – 6 min, (d) open section – 11 min, (e) flame propagation – 18 min, (f) near end of test – 29 min, (g) after test, and (h) back of fence.

| Time<br>(mm:ss) | Event |
| 00:00 | Start test – ignition of excelsior bed (previously poured ethanol) |
| 00:30 | Fan (2.1 m/s) turned on |
| 01:30 | Glowing on east (untreated) fence in joints |
| 02:50 | Flames on base of east fence |
| 05:45 | Flames to 4 <sup>th</sup> east board |
| 10:00 | Open/broken section of east fence |
| 12:45 | Flames to 6 <sup>th</sup> east board |
| 16:45 | Flames to 9 <sup>th</sup> east board |
| 18:30 | Flames to end of east fence |
| 23:00 | Most of east boards broken |
| 25:00 | Mulch at the base of fence glowing at west fence up to 3 <sup>rd</sup> board |
